# Manhole Inspection Summary

## Manhole # S11GG1019MH

Insp Date: **2/9/08 11:16 AM**

**Location** Address: **2810 W COLD SPRING LANE** Cross Street: **TOWANDA AVE**

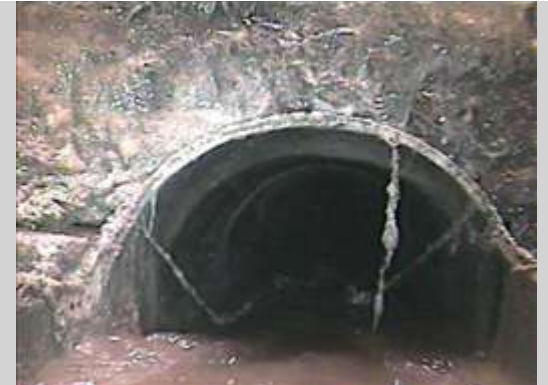
12 O'Clock Outflow

15 in. Circular Gravity Sewer  
Pipe Out @ 12 O'Clock

Pipe Height: (in.) Direct  
Pipe Material: **Clay** ☐ Pipe Lined  
Invert Depth: **14.52** (ft.) Flow Characteristics: **Fast**  
Deposits: ☒ None ☐ Mud ☐ Sludge ☐ Debris ☐ Grease  
Silt Depth: (in.) Deposits Extent:  
Infiltration: **None** Pipe Seal Cond: **Sound**

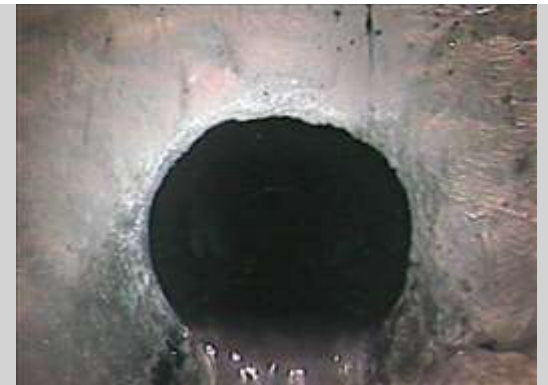
3 O'Clock Inflow

8 in. Circular Gravity Sewer  
Pipe In @ 3 O'Clock

Pipe Height: (in.) Direct  
Pipe Material: **Clay** ☐ Pipe Lined  
Invert Depth: **13.50** (ft.) Flow Characteristics: **Fast**  
Deposits: ☒ None ☐ Mud ☐ Sludge ☐ Debris ☐ Grease  
Silt Depth: (in.) Deposits Extent:  
Infiltration: **None** Pipe Seal Cond: **Sound**

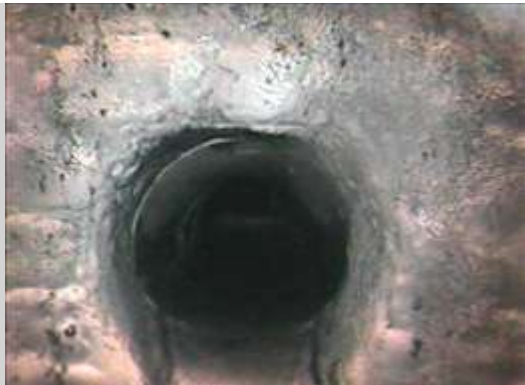
9 O'Clock Inflow

Pipe In @ 9 O'Clock

Infiltration: **None** Pipe Seal Cond: **Sound**

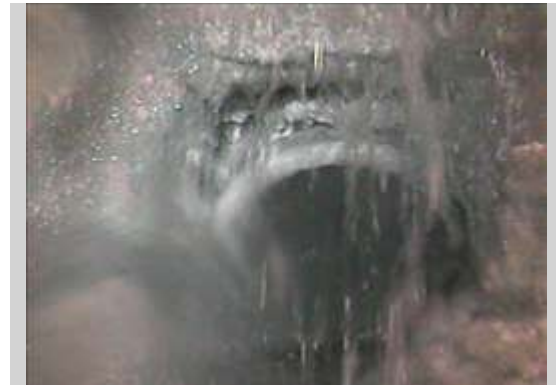
Drop In @ 9 O'Clock

Drop: **Outside Direct**

Drop Condition: **Open**
